**Johnny Carson Park** is one of the largest and most utilized neighborhood parks within the City of Burbank. Throughout the park's history, the site has lost and gained several acres. Currently, the park stands at 17.60 acres and approximately 8.75 acres of the park are City-owned. The park also provides extensive local, regional, environmental and social benefits.

AREA OF STUDY

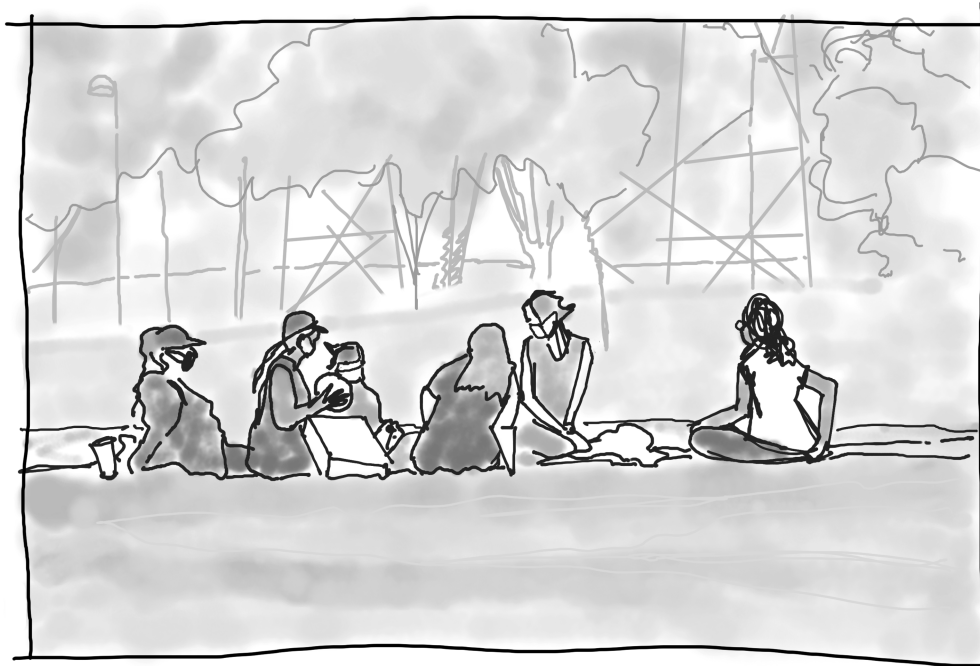
OBSERVATION ANALYSIS 1

- Group of women gathering to celebrate a birthday or event that involves cupcakes
- They are in the sports field area, off from the center of the play field, in the full sun
- They also have fast food lunches
- All are masked and socially distant
- All are wearing sports attire
- Sports equipment is nearby (soccer ball)
- Most look late 20's, one is younger, maybe 14
- Relaxed, laughing, like they all know each other well
- Active area
- Grass is full, but mowed for ease in playing

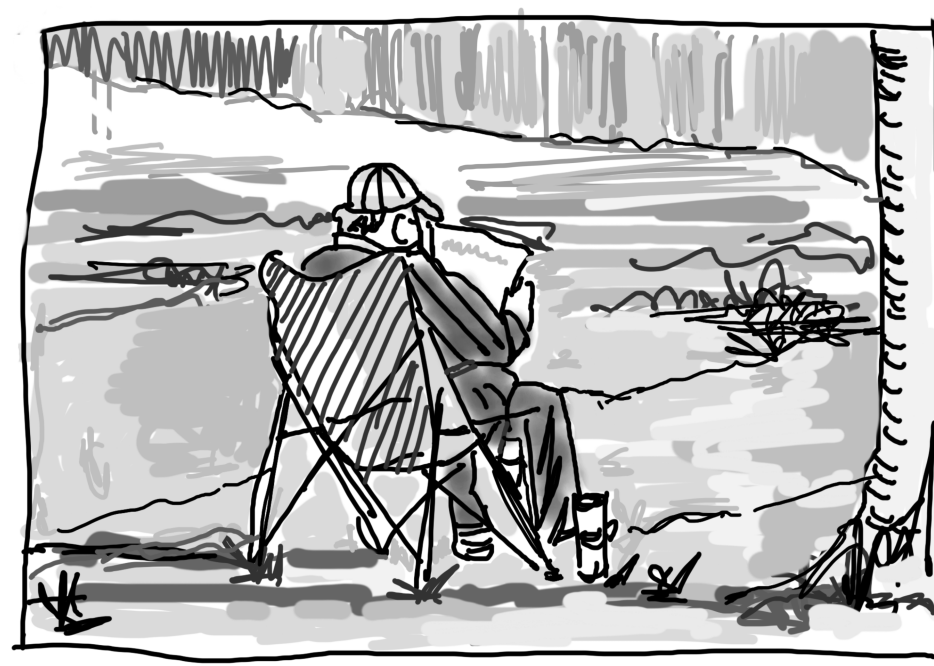
OBSERVATION ANALYSIS 2

- Older gentleman, 70's, reading the sport's page
- Brought his own folding chair
- Dressed warmly for the weather
- Sitting in the shade of the upper field northeast near entrance off Parkside Drive
- Brought his own coffee and snacks
- Enjoying the solitude of this section of the park
- He is near easy-to-get-to parking, off the main streets
- This area has a side view of the whole creek and lower part of the park, but is away from the freeway traffic noise
- Passive area
- Grass is full, but mowed for ease in walking
